L' Aquila Earthquake, Abruzzo. Italy May. 06, 2009 $M_w=6.3$ – Lifeline Performance

Alex Tang¹, PE, F. ASCE, and Thomas R. Cooper², PE, M. ASCE

Executive Summary

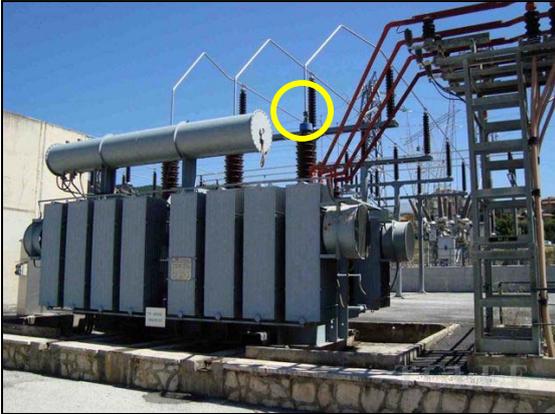
It was reported that two substations serving the greater L'Aquila had damaged connections between a rigid bus and insulator, Figure 1. That was due to shifting of the un-anchored transformers during the earthquake. Also due to sloshing of the cooling oil within the transformer, cooling oil pressure increased, and actuated the safety shut off feature to avoid costly damage. One of the transformers moved about 14 cm.

Figure 1. The rigid bus connection at the top of the transformer was damaged during the earthquake.

Anchoring equipment should be the priority in securing lifeline equipment. Even in cases where there was no damage from this event, it is still important to positively secure equipment, both functional and non-functional.

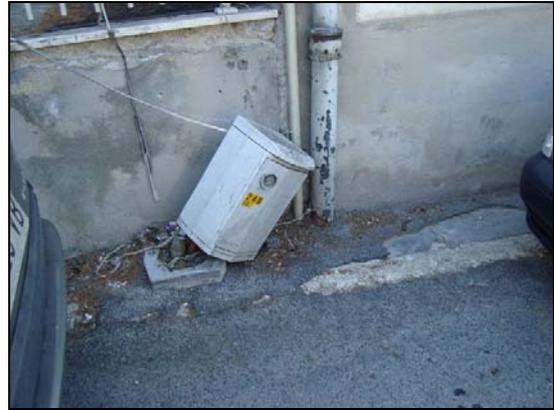
In the distribution system, 30 posts were damaged causing severed links that resulted in service disruption. More than 180 pedestal type connection boxes (Figure 2) were dislocated and severed cable connections at the termination lugs that resulted in localized power failure.

Figure 2 A lot of this type of low voltage distribution connection boxes was damaged resulting in power interruption.

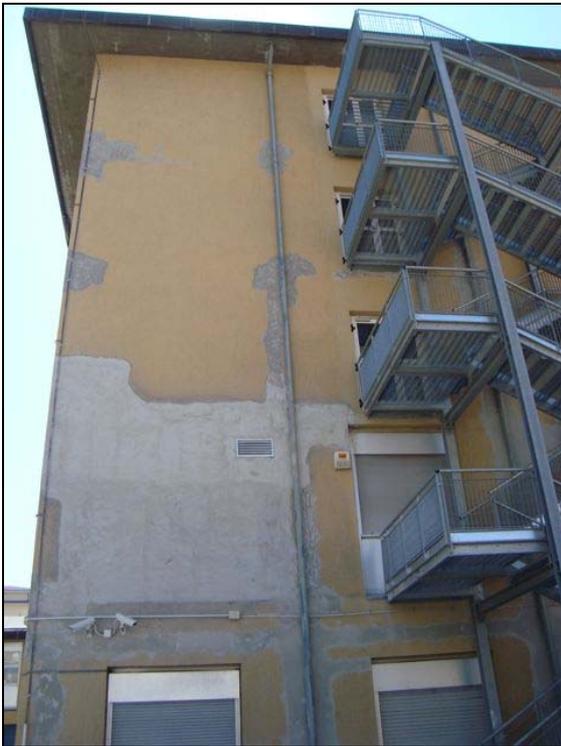
The Electric Power Control Center at L'Aquila sustained sever damage (Figure 3), both building and equipment, and it had to be moved to a temporary building in the yard of the building premise. It took three days to complete the move, while the essential part of the system was functional by 9 AM the day after the earthquake (Figure 4).

Figure 3 The electric power network control building was damaged and repaired.

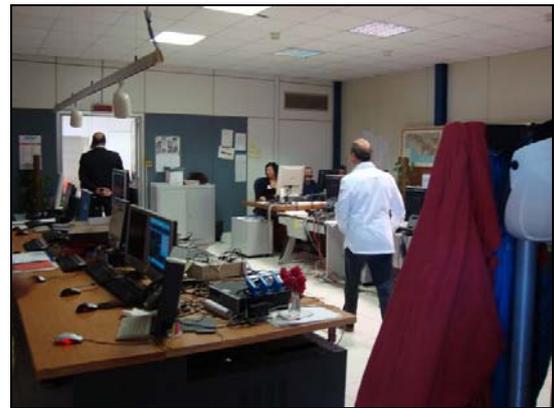
Figure 4 The temporary electric power network control room was set up and operational within 12 hours after the earthquake.

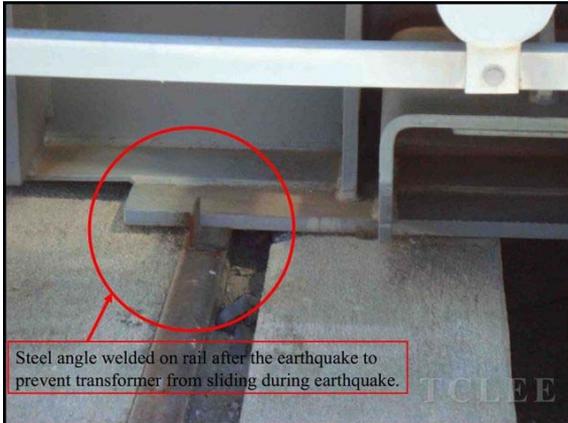
Transformers in substations were not anchored. We noted that steel angles were welded on the tracks that the transformers were supported to stop sliding, Figure 5. This was done after the earthquake. However the steel angles seemed to be under sized.

Figure 5 Steel angles were welded to prevent the transformers in substations from sliding after the earthquake.

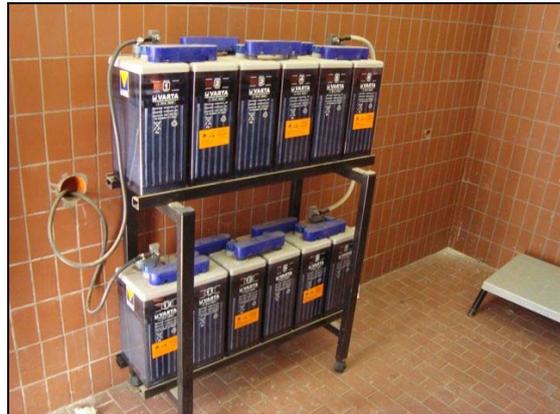
In the control house of substations, the batteries were not anchored or tied to the racks, Figure 6. There was no batteries damage reported at these substations.

Figure 6 Unanchored battery racks and the batteries on the racks were not secured were common in substation control rooms.

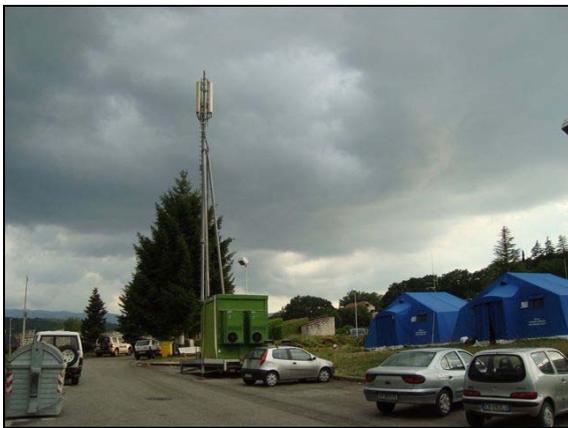
Figure 7 Many temporary cell sites like this shown were set up to compliment the landline communication service.

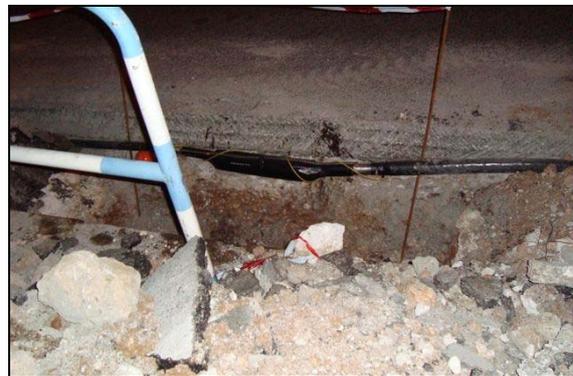
A number of landlines were damaged or severed, as repairs were evident during our investigation, Figure 8. Since tenants were not allowed back to their houses or apartments, most landlines were not used. Hence the demand on this circuit became much lighter.

Figure 8 Underground telecommunication landlines were damaged and being repaired.

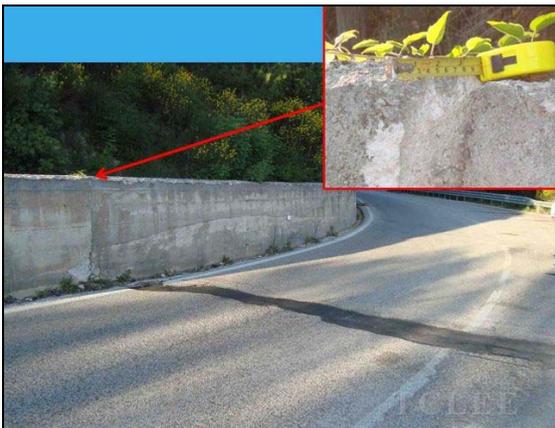
We did not observed any other significant damage that would impair the transportation system of the region. On highway SS80 leading to the Lake Campotosto where we planned to inspect the three dams of this lake, we came across a couple of sections of slumping damaging about 30% of the width of the south bound lane, and a failed retaining wall of the abutment of a bridge, Figures 9 and 10.

Figure 9 Some part of the State highway SS80 was damaged, this shows the displacement of the retaining wall and surface crack on the road surface. The offset was about 9 cm.

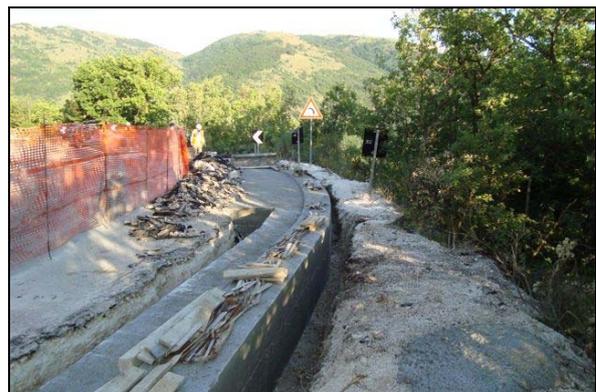
Figure 10 Road surface rupture repair was in progress.

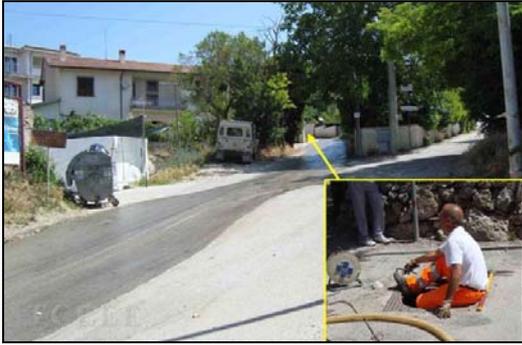
When visited Paganica, through a trail of water running down hill, we met a repair crew was working on a shut off valve in the manhole, Figure 11. While on the other side of the town, there was a new transmission pipe along a small slope replacing a damaged one. This transmission pipeline was still exposed.

Figure 11 A water valve in a manhole was being repaired in Paganica.

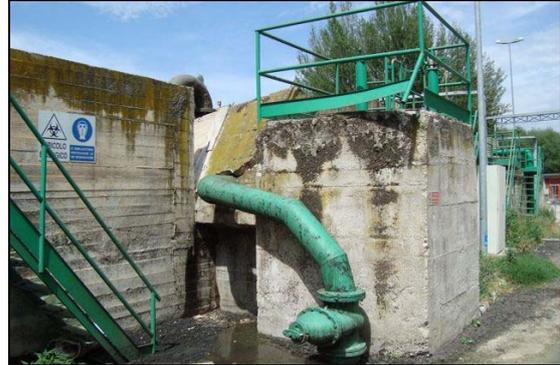
There were two wastewater treatment plants serving the greater L'Aquila area. The older treatment plant had sustained significant damage to the aeration tank wall spilling unpleasant liquid, Figure 12. It was cleaned up and part of the facility was closed. The affluent intake pipe joint was also damaged during this earthquake, Figure 13.

Figure 12 This aeration tank in the old wastewater treatment plant was damaged. Note the wall of the tank collapsed. The dirt water spilled all over.

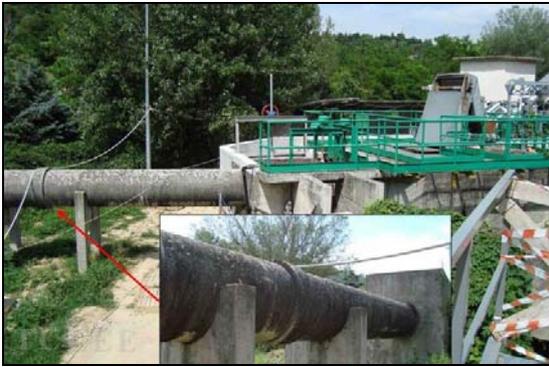
Figure 13 The waste intake pipe at the old treatment plant was dislocated at the joint, leaking dirt water.

Flexible joints of pipes at transition points should also be a common practice.

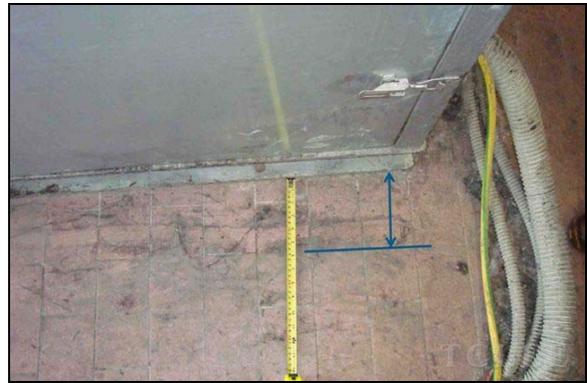
At the newer treatment plant, power was off for three days. This site ran on its own backup power generator for the three days to deal with wastewater in the area. A pipe connected to the pump in the control room was damaged due to shifting (about 15 cm) of the unanchored pump, Figure 14.

Figure 14 The pump in the control room of the new wastewater treatment plant was not anchored and shifted during the earthquake. It shifted about 15 cm.

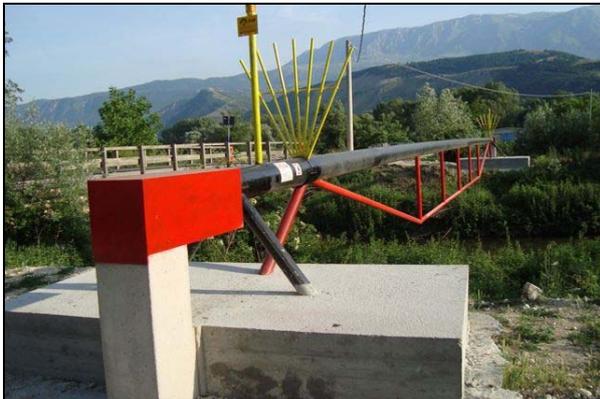
We visited a location close to the town called Onna where a small gas pipeline crossed a small creek. The pipeline was damaged and was replaced with a new pipeline. There were two new concrete abutments on either side of the crossing that supported the pipe. The pipe was rigidly connected to the abutment with no flexible connection between the pipe and the bridge foundations, Figure 15.

Figure 15 This new gas pipeline replaced the old damaged one in Omna. Note that the pipe is fixed on the concrete block.

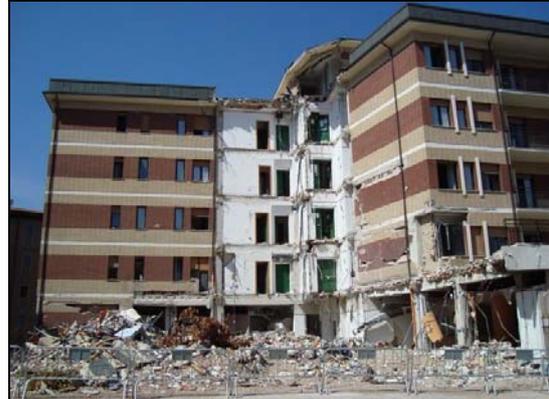
The University of L'Aquila had several buildings damaged, classes were moved to temporary sites around the city. A portion of a university student residence collapsed with the remaining portions severely damaged, Figure 16.

Figure 16 The student dormitory was severely damaged with one part collapsed.
