Italian Joint Reconnaissance Mission

Türkiye

May 8th – 13th 2023

Daily Report
May 12th 2023

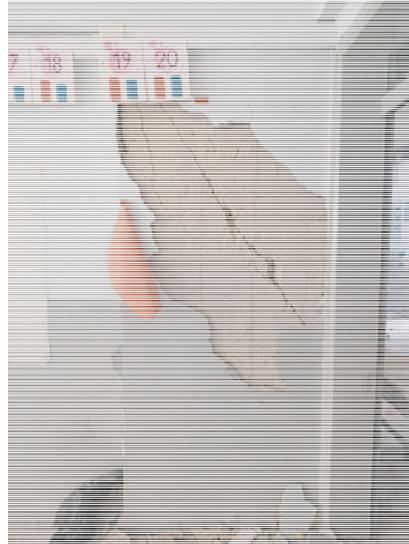
- **MUSTAFA KEMAL AKBAY İLKOKULU**

Fig. 2. Shear failure of an RC wall at the ground floor.

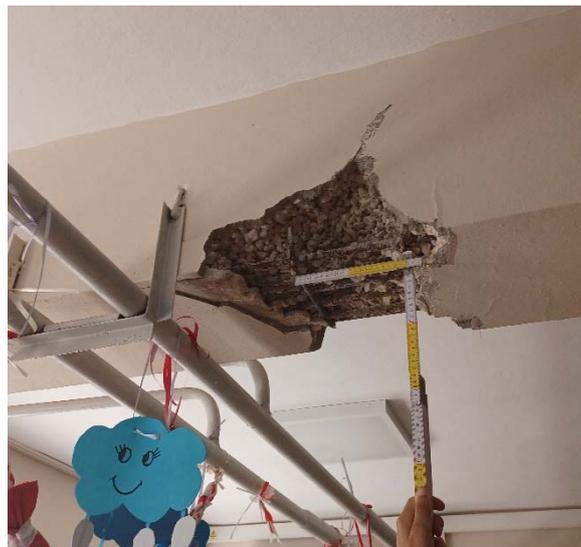
- **DURSUNLU GAZİ ORTAOKULU**

Fig. 3. Local damage in a ground floor beam, at about one-third span's length away from the nearest supporting column, at a point where heating pipes are suspended from the beam's web. Damage most probably attributed to bad quality concrete (presence of large voids and lack of hardened cement paste) and (likely) interaction with the pipe.

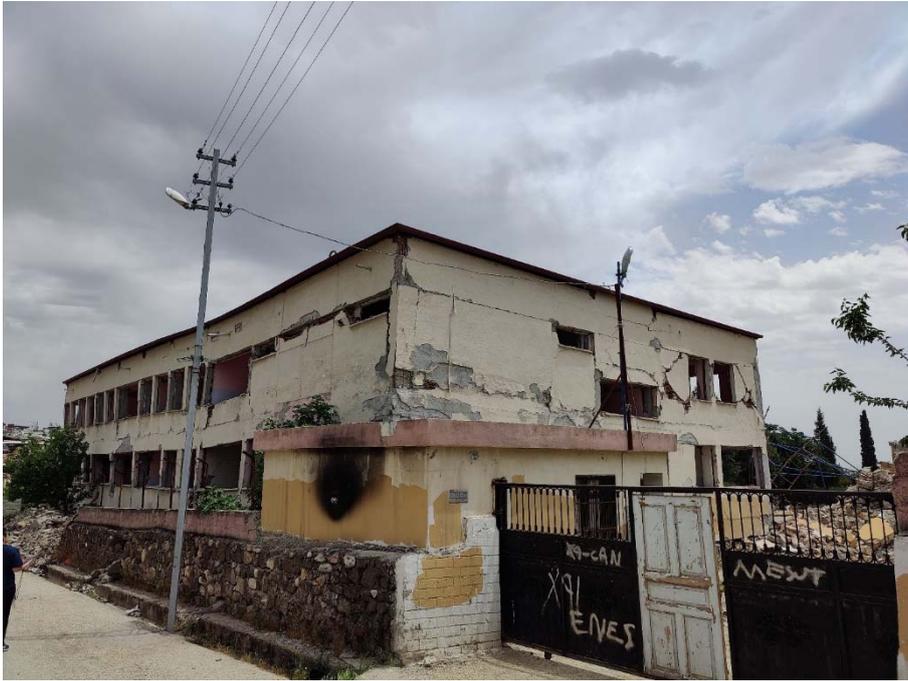
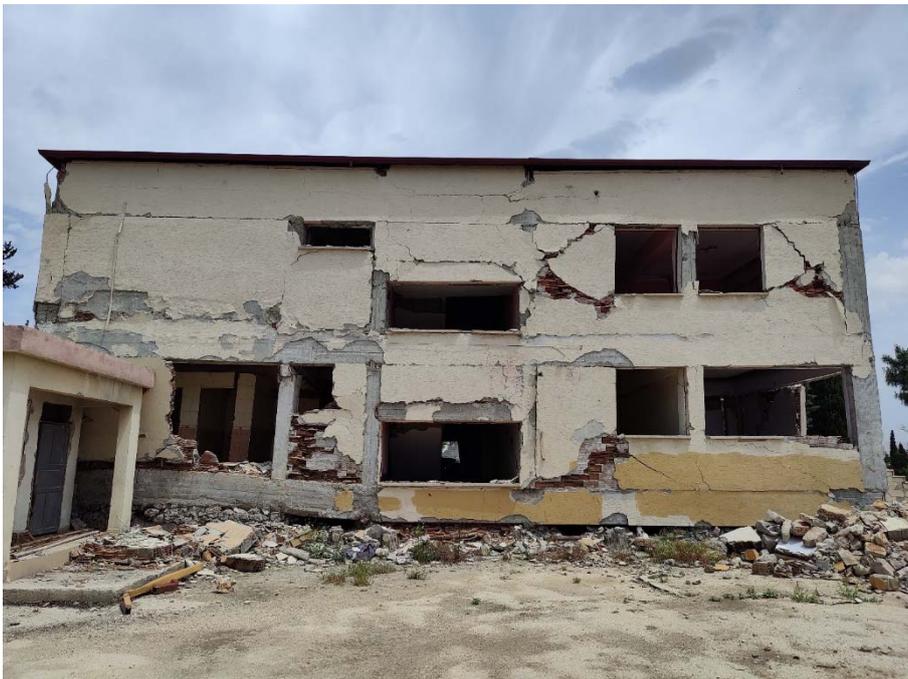
- **KAYMAKAM HASAN ZENGİNALP İLKOKULU**

Fig. 4 – Prospect view of the building exhibiting widespread damage (no documented pre-earthquake retrofit).

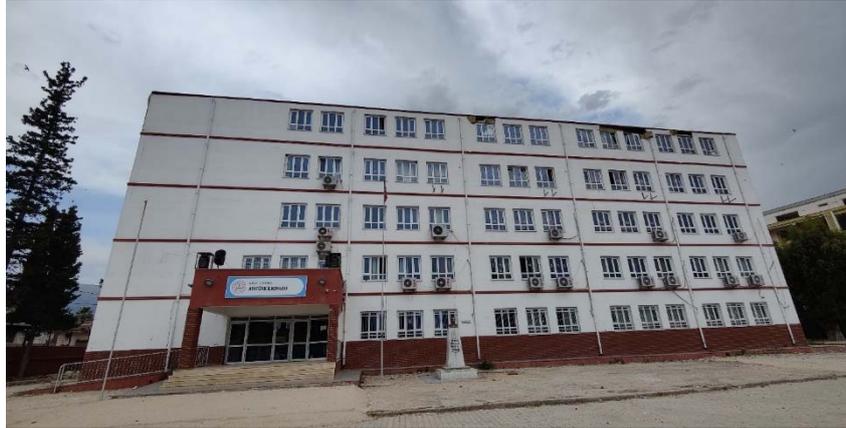
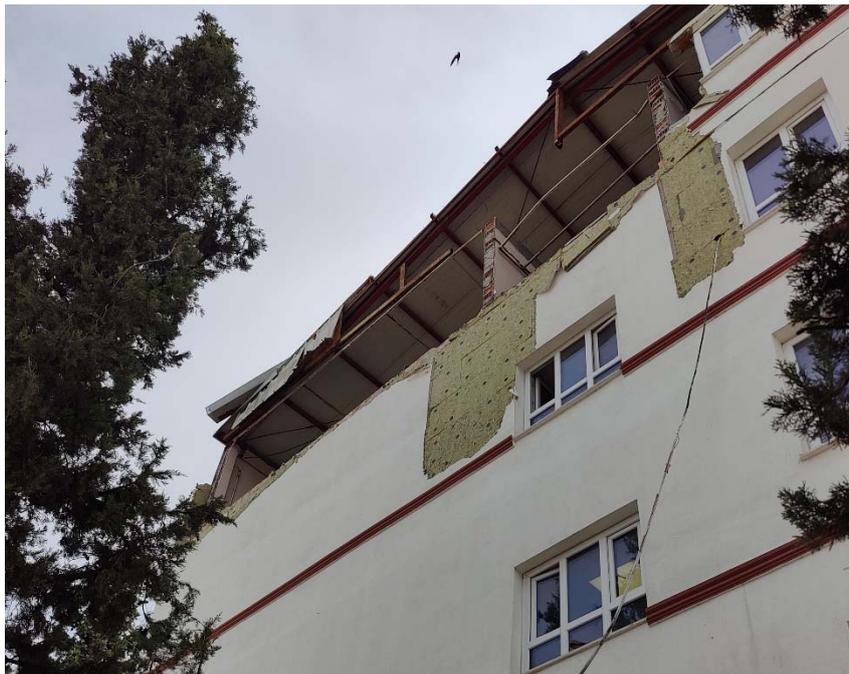
- **ATATÜRK İLKOKULU**

Fig. 5 – Front view of the building; out-of-plane collapse of the top floor’s masonry infills (building retrofitted via addition of shear walls prior to the seismic sequence).

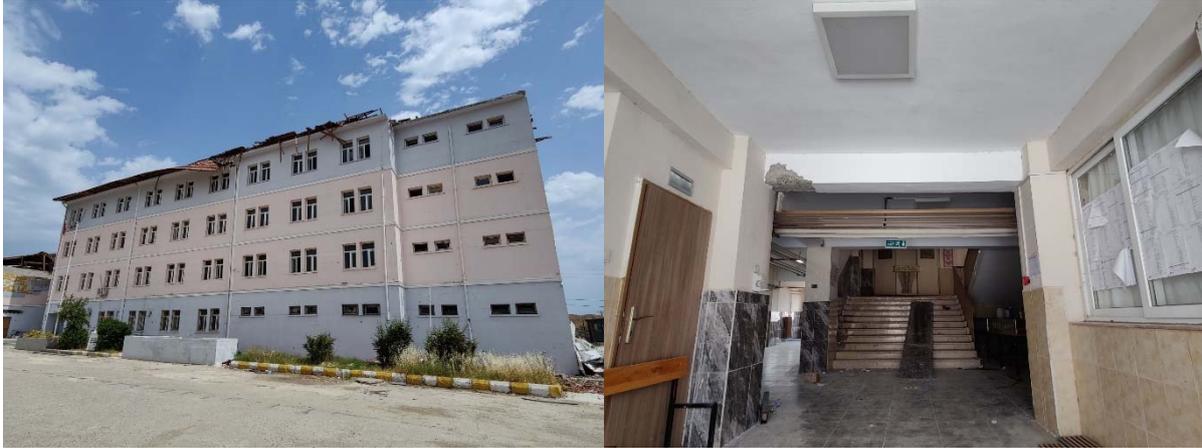
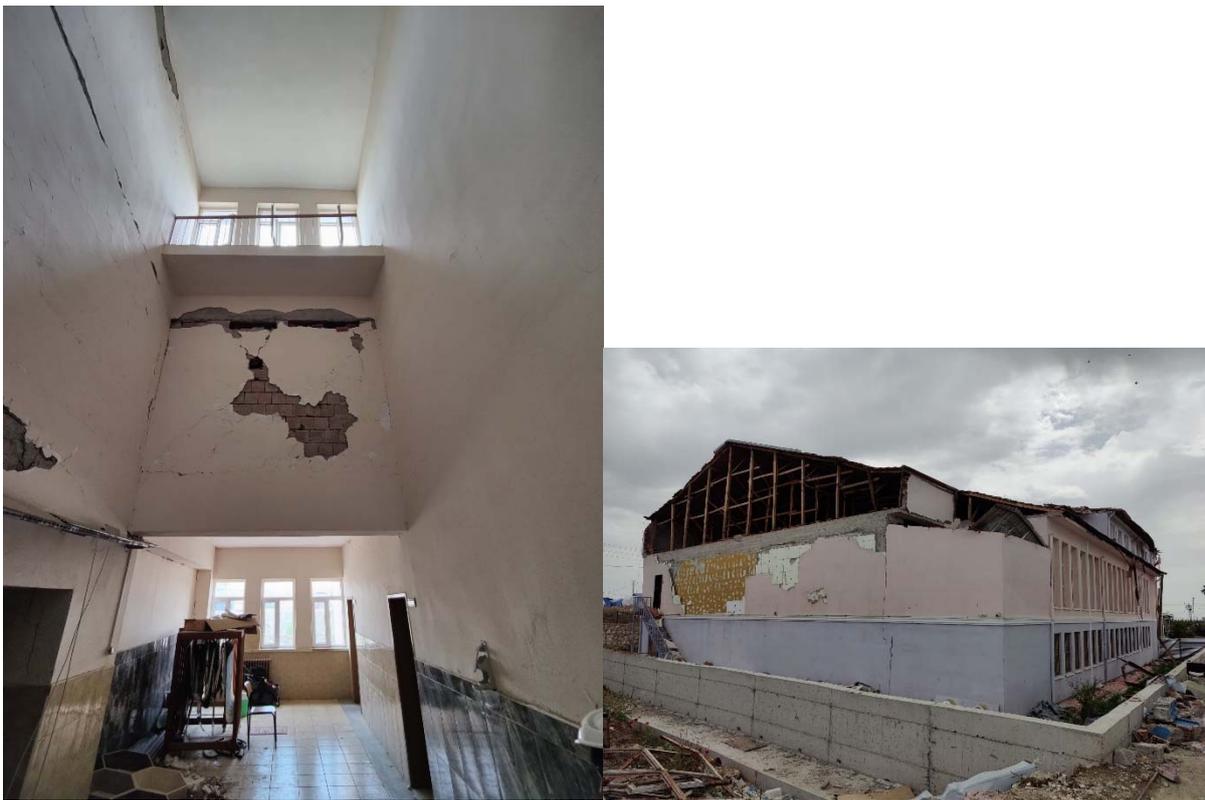
- **KIRIKHAN MESLEKİ VE TEKNİK AL**

Fig. 6 – Front view of the building, flexural cracking of a beam, damage of the masonry infills and damage to the roof cover.

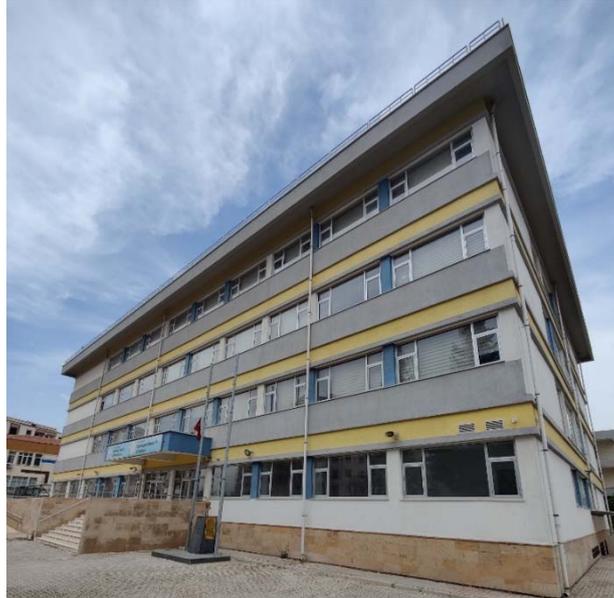
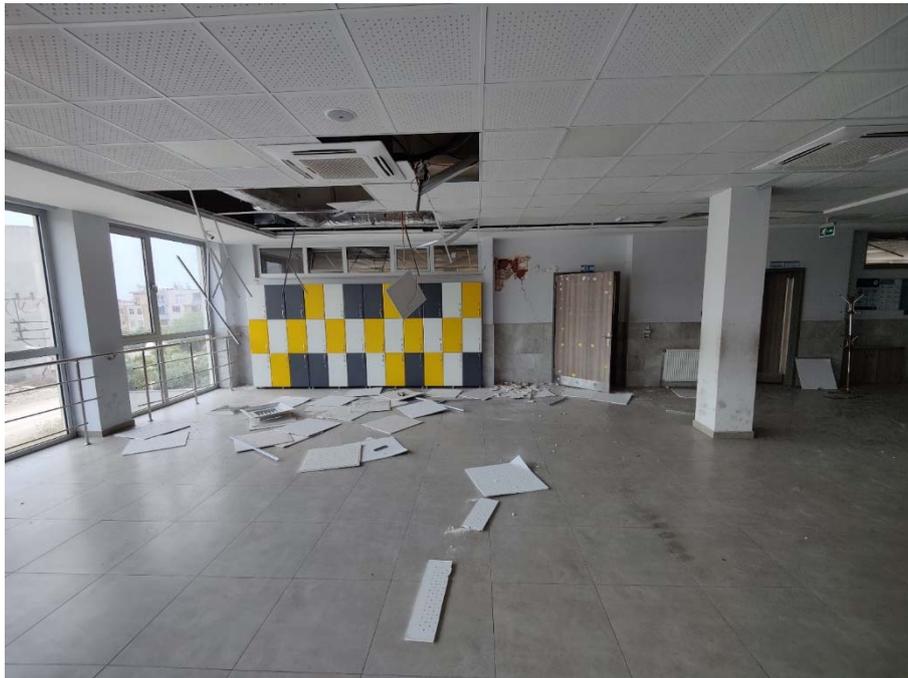
- **YUNUS EMRE ORTAOKULU**

Fig. 7 – Front view of the building and fallen suspended roof panels.

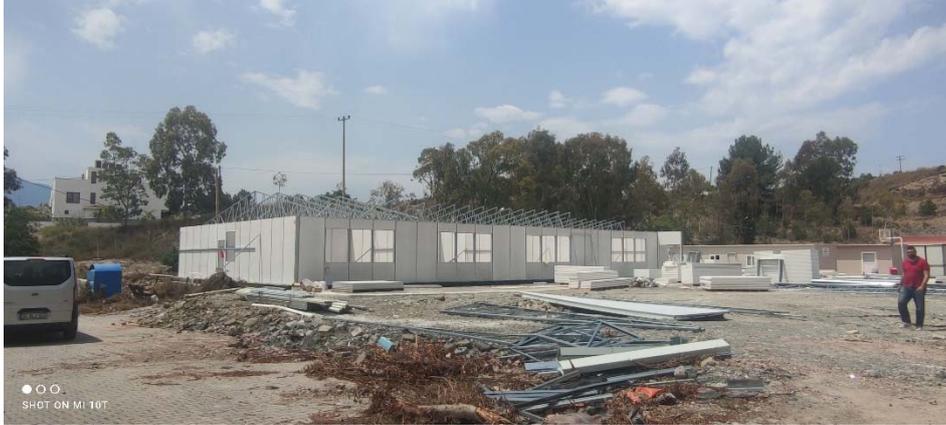
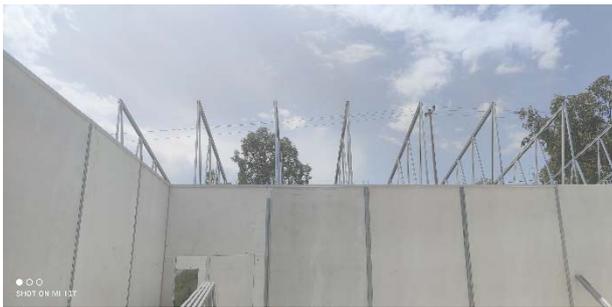
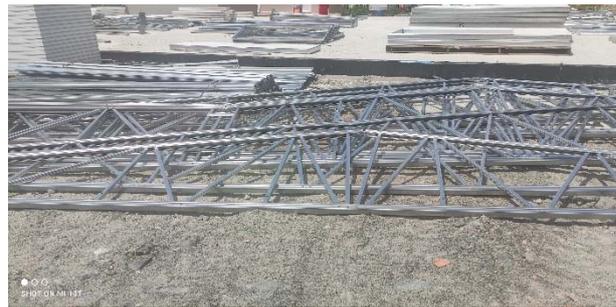
- **ULUÇINAR İLKOKULU**

Fig. 8 – Original school building has been demolished despite lack of serious damage and is being replaced by single-storey building (a), using prefabricated sandwich panels with polystyrene (b) and roof structure consisting of lightweight aluminum trusses (c). The choice of structural system was dictated by the low bearing capacity of the foundation soil, which led to opting for replacement with a lighter structure, rather than retrofitting the existing structure with shear walls.

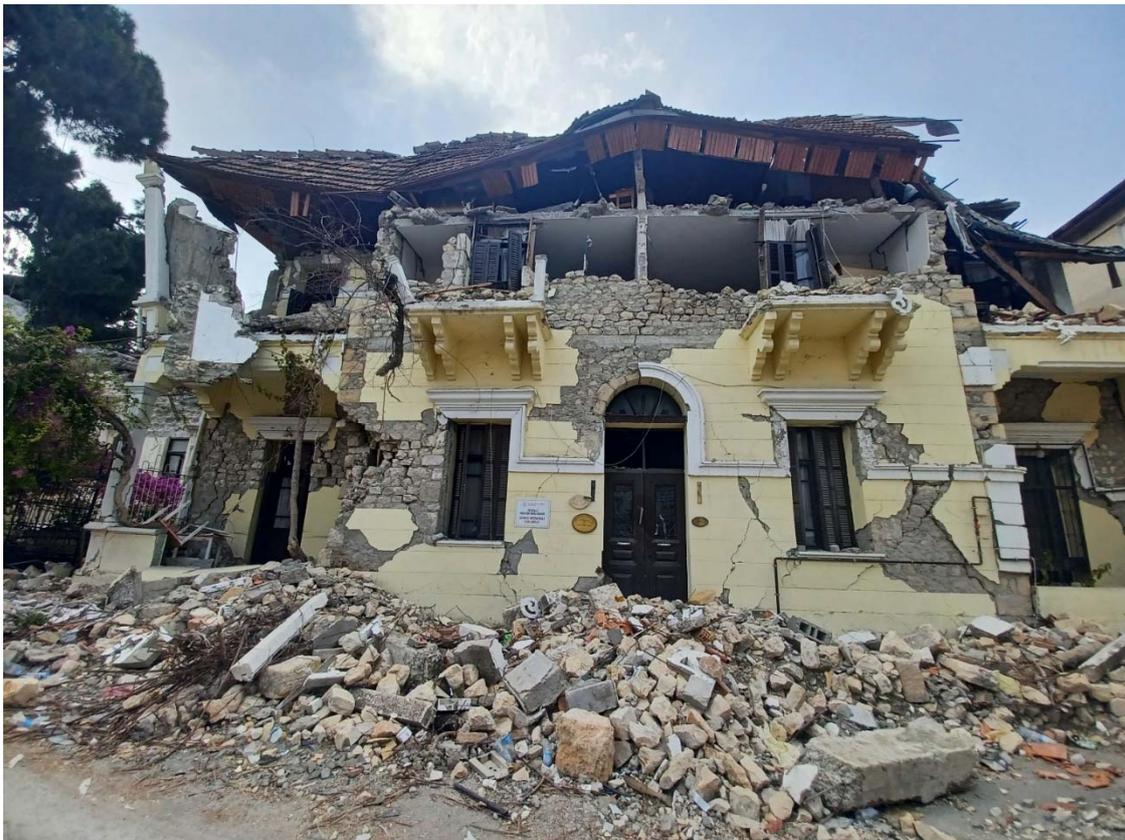
- **City of Antioch (Antakya)**

Fig. 9 - Damage state of a stone masonry building in the historic city-center of Antioch: collapse of the roof, in-plane and out-of-plane failure mechanisms of the masonry walls. The cantilevers of the balconies overlooking the main entrance have survived, oddly enough.

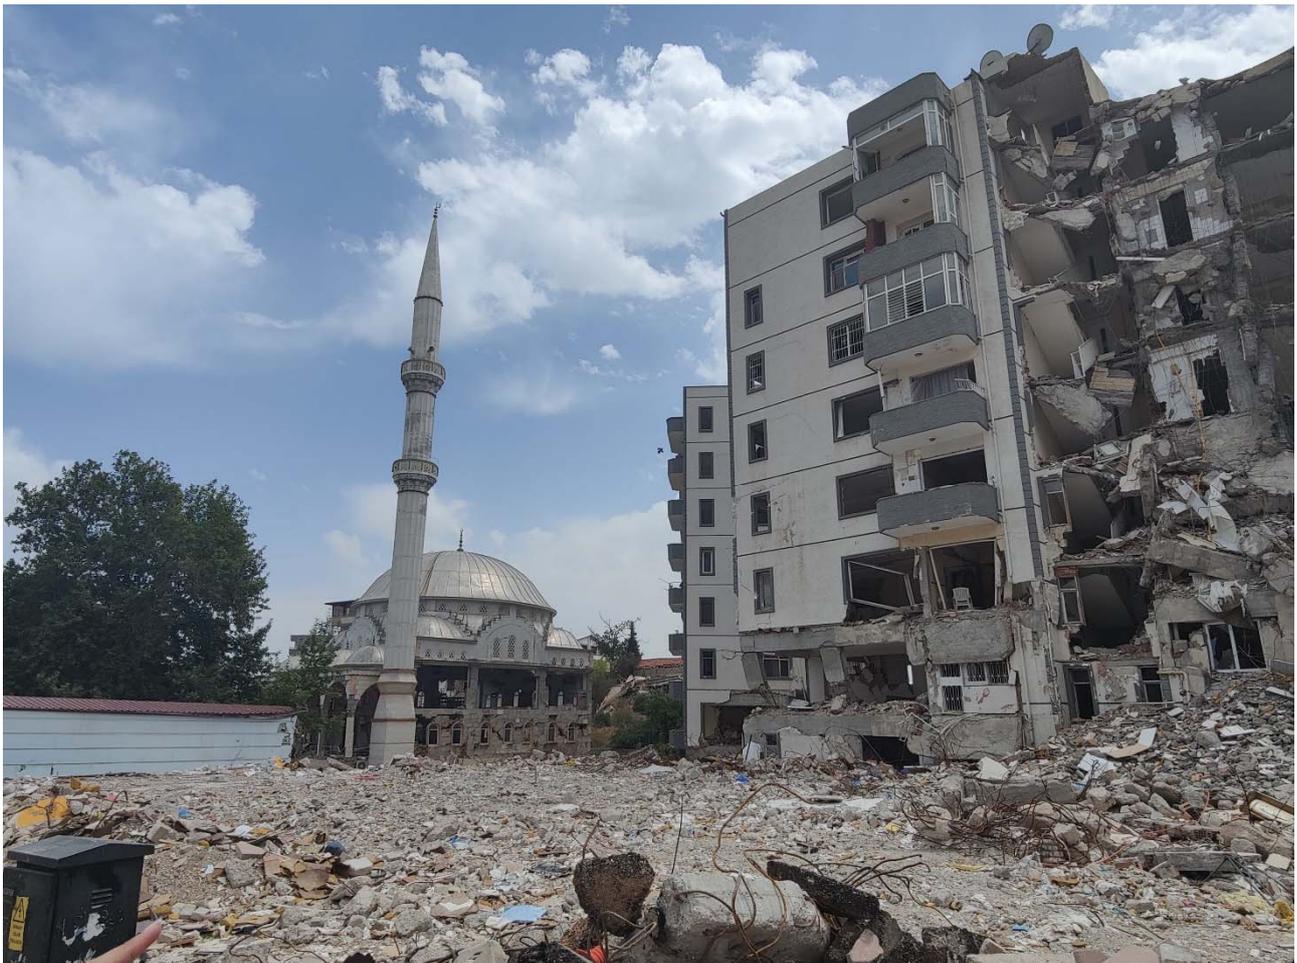
- **City of Kirikhan**

Damage was encountered in a residential building in downtown Kirikhan, visible on the right-hand side of Fig. 10, where one can observe a floor-sway failure mechanism on the first two elevations of the left portion of the building and partial pancake collapse on the right portion. On the left-hand side of the picture, a mosque is visible, with evident damage on the external front walls, in the form of shear cracks and an apparent deviation from the vertical position of the minaret, which does not seem to have suffered other serious damage.

Fig. 10 – Residential complex in downtown Kirikhan.

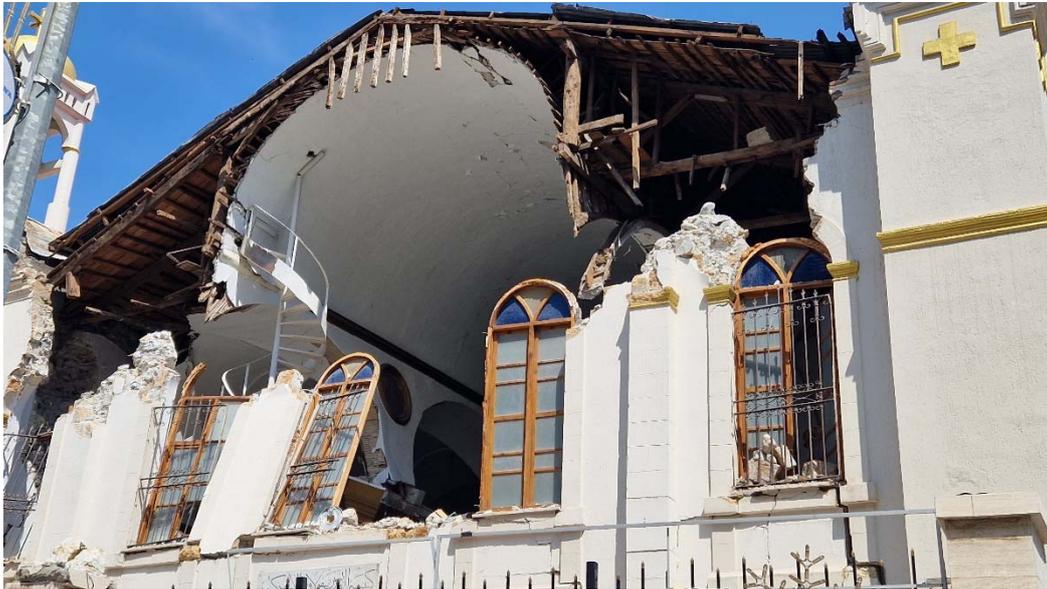
- City of Kahramanmaraş

Fig. 11 – Collapse of the frontal wall of a masonry church with a wooden roof.

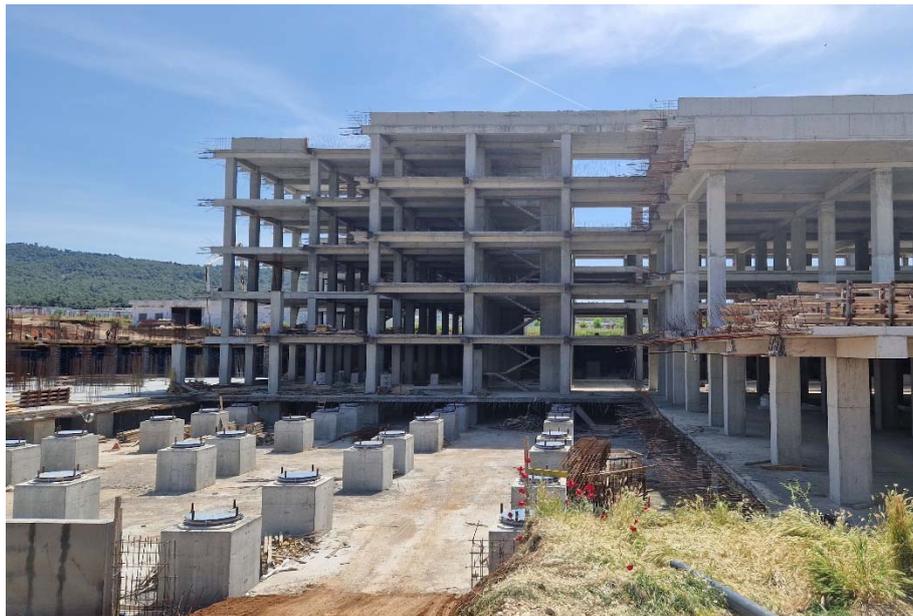
The building still under construction is a cast-in-situ RC structure and avails of a base-isolation system, supported by a bore pile foundation, where the piles were connected via a 1.5m-thick RC foundation slab acting as pile-cap. The deep foundation system was presumably adopted due to the poor bearing capacity of the soil. The base-isolation system consisted of 361 1.0m diameter, double-curvature friction-pendulum isolators, with maximum stroke of $\pm 1000\text{mm}$, which was justified by the construction site manager as a design choice dictated by the vicinity of the site to the fault (distance of less than 10km). The isolators' dimensions are compatible with the displacement spectra derived from the acceleration records obtained at nearby stations.

On the perimeter of the first elevation floor slab, a 2.0m span of RC slab cantilevers out. This perimeter cantilever ends at a distance of 4.0cm from the rim of the underlying retaining wall. After the earthquake, an approximate measurement indicated that the residual displacement of the isolation devices was around 3.5cm.

Fig. 12 – Side view of the structure under construction.

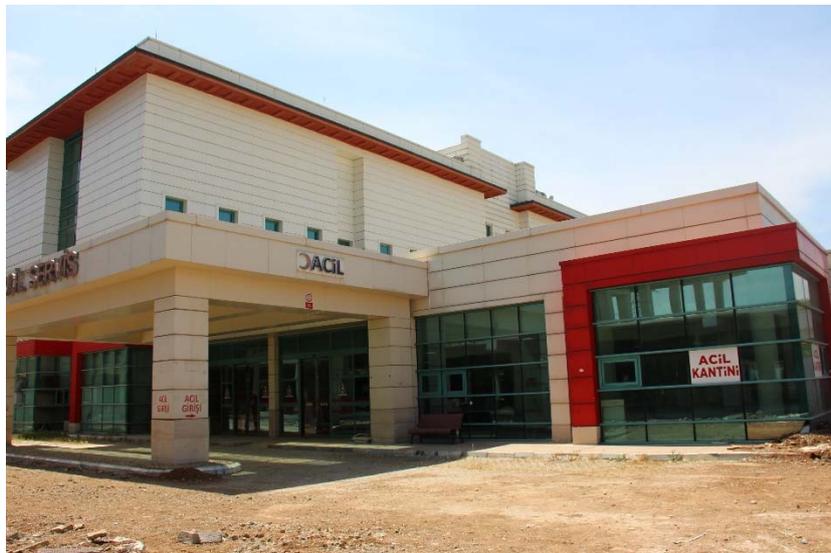
The second structure under inspection (the existing one), has a more traditional lateral-load-bearing system, comprised of mixed RC frames, that is frames connected to shear walls, with monolithic connection to the foundation. That structure was found to exhibit damage at the end sections of the linear (beam/column) elements in the vicinity of the stairwell. Further damage was observed at the masonry infills (Fig. 14) and non-structural components.

Fig. 13 – Existing hospital building built in 2012.

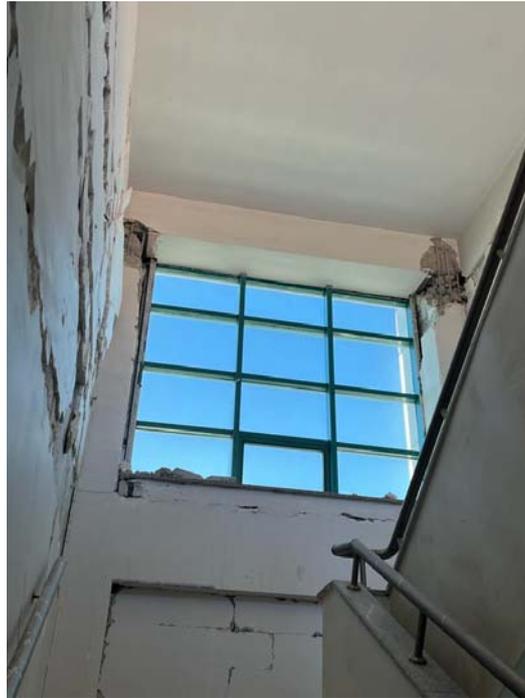
Fig. 14 – Damage encountered in the existing structure.
